Memorandum
Perimeter Berm Construction
Steve Trettel, P.E

DATE: April 24, 2007
TO: Mike Quatromoni
FROM: Steve Trettel, P.E.
SUBJECT: Crow Lane Landfill, Newburyport, MA
Perimeter Berm Foundation Stability

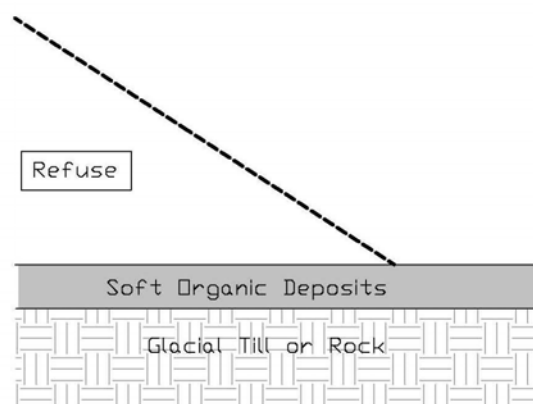
The most factual and convincing evidence that peat was removed from within the foot print of the berm before berm fill was placed is the factual stability of the berm as constructed. Because the original landfill was pushed out over the existing swamp when it was constructed in the 60's and 70's swamp deposits (peat and organic silt) was located below and outside of the existing Toe of Slope. These deposits were found to vary from 2' to 4' thick. The physical characteristics of these deposits is high compressibility and very low shear strength (Figure 1).

Figure 1
Pre Construction Condition at Toe of Landfill

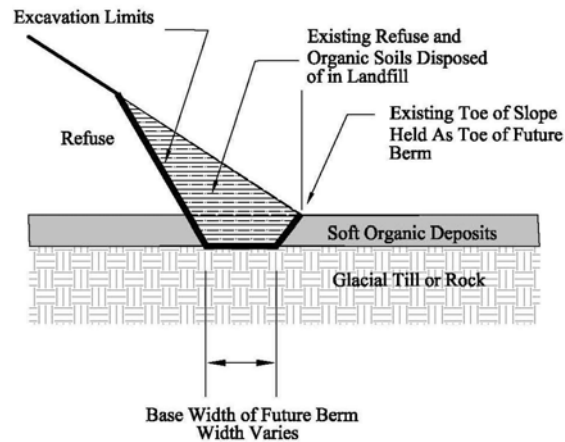
New Ventures in initial construction work was to prepare the foundation for the perimeter berm as shown on Figure 2:

Figure 2
Berm Foundation Preparation

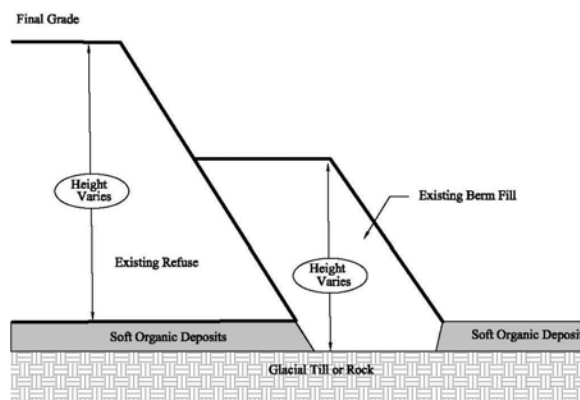
Berms were then constructed of clean granular fill to various heights in accordance with proposed final grades or interim levels of refuse fill. The most extreme current conditions with respect to loading of the existing berm is on the west side.

Figure 3
Current Geometry

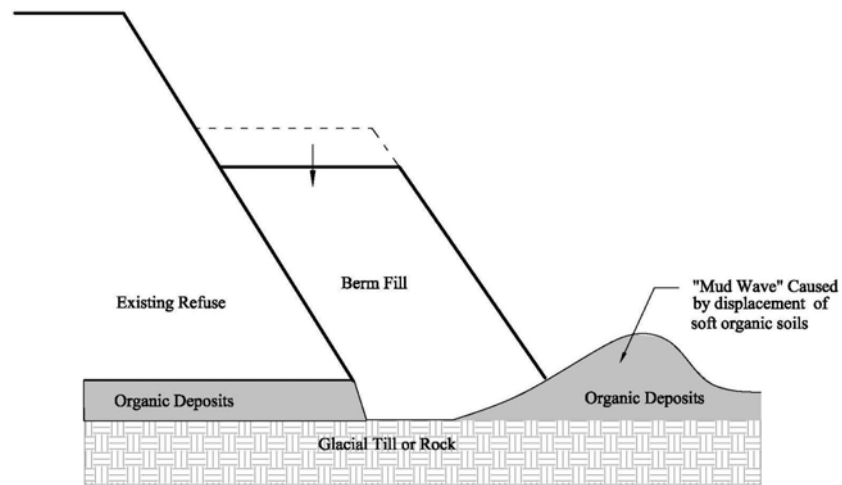
It is self evident that had the highly compressible, low strength organic deposits been left in place under the berm fill one of the situations illustrated in Figure 4 would have already occurred:

Figure 4A
Mud Wave

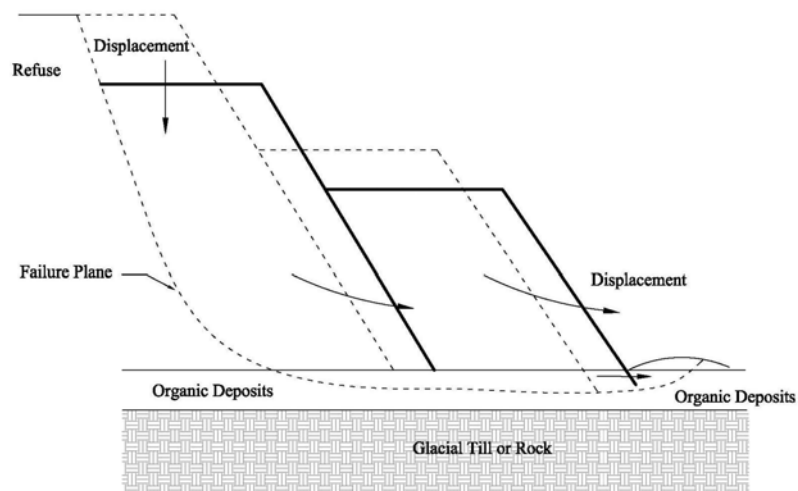
Figure 4B
Sliding Failure and Displacement

Any slope stability analysis performed with the assumption that the organic deposits characterized by very low shear strength (negligible) and very high compressibility would result in a factor of safety well below zero.

The obvious conclusion is that the existing berm on the west and part of the north side would have failed during construction let alone remained intact and stable at its current height and the height of refuse behind it unless the soft organic deposits had been totally removed as previously stated.
